TALE OF A RIVET ELISSA 2012-13 Hull & Deck Restoration

~ELISSA REDIVIVUS~ 2012 RESTORATION

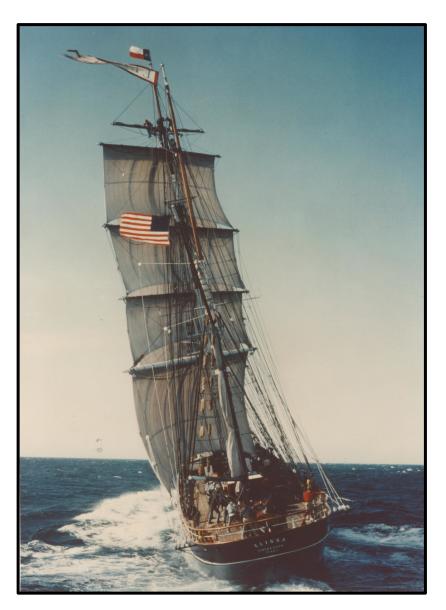
Electrolytic corrosion resulting from Hurricane Ike

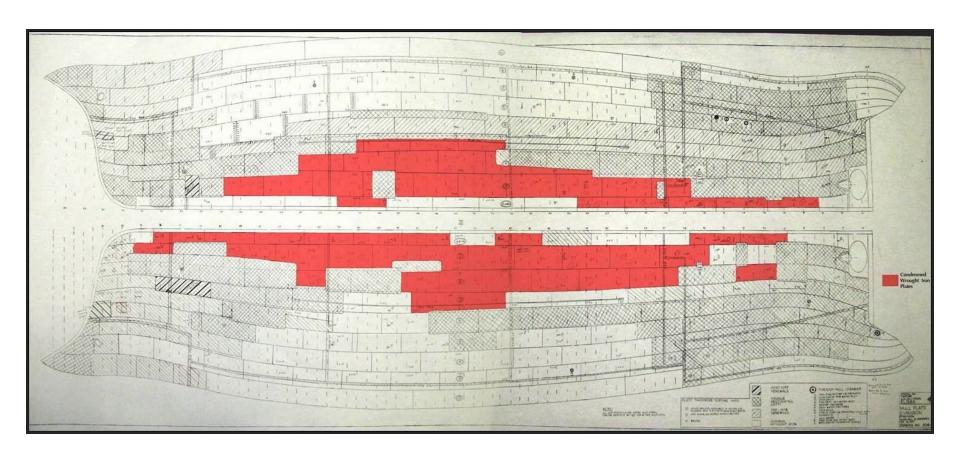
The Coast Guard directed us to renew 51 hull plates (red areas on hull plate expansion diagram).

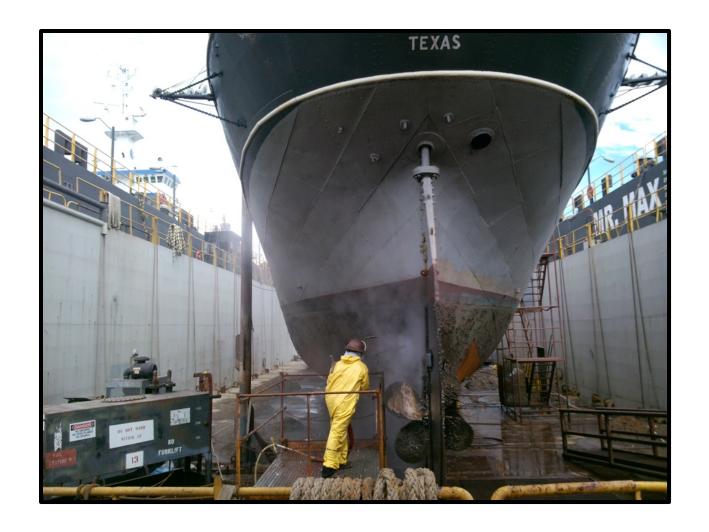
The 40,000 psi cleaned the iron and steel shell plating exceptionally well and revealed the areas of corrosion first discovered at last year's dry-docking. It exposed some further areas of corrosion that were not exposed at last year's dry-docking, when we used a less aggressive and less costly method.

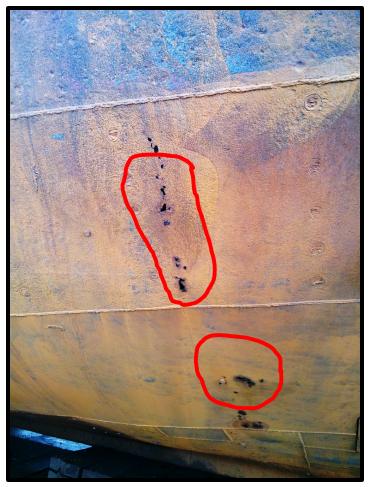
The concentrated pressure of 20 tons on an area no larger than a postage stamp revealed areas of electrolytic corrosion not uncovered during the prior dry-docking in 2011.

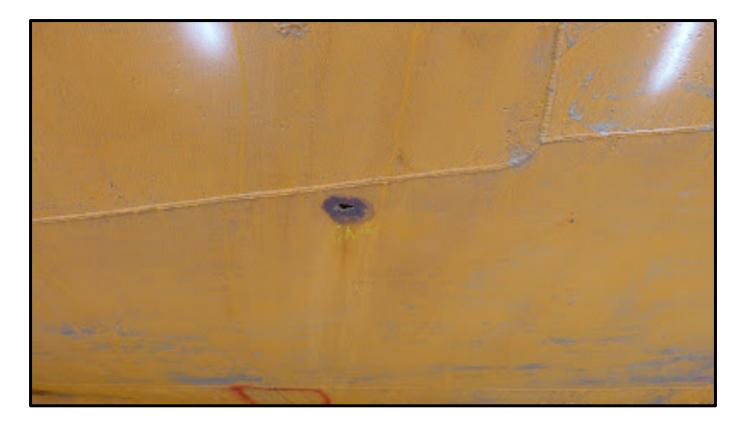
The photo above is another one of the areas of corrosion that was discovered during Elissa's last dry docking. This is in welded steel plate renewal done 30 years ago in Greece and will be repaired with a welded insert. Inserts are a repair that is considered permanent and stout.

The minimum area to be removed for an insert is 18" x 18" inches and it must span a frame. Even though this hole is the size of your fingernail, an insert of 18" x 18" will be necessary to repair the corrosion damage.

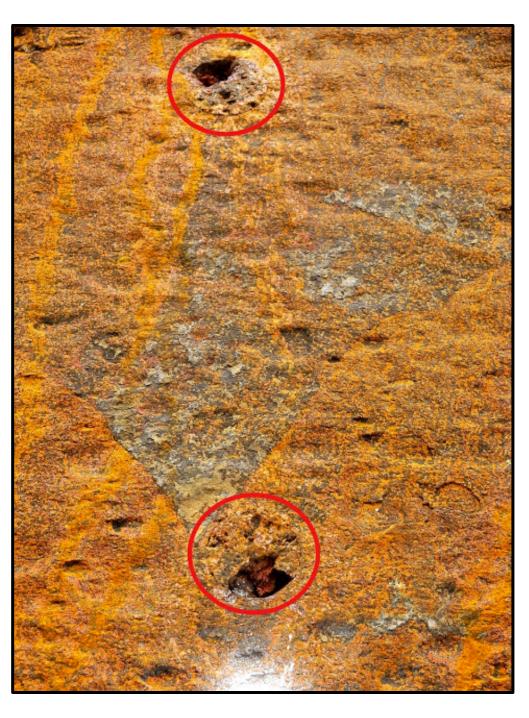
Not only was the hull plate attacked by the electrolytic corrosion - rivets fell equal prey.

Here is an example of the corrosion of the rivet points on the hull plate that will need to be either drenched or renewed with new rivets.

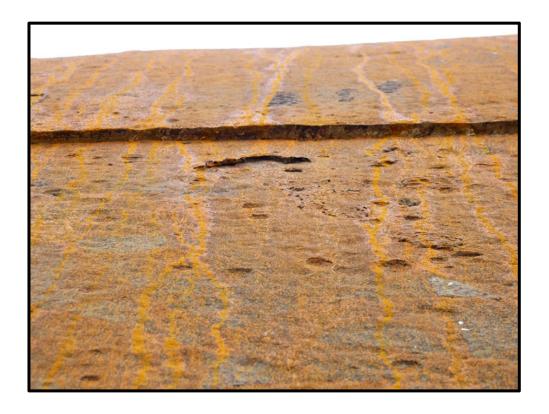
Another type of damage is the delamination of some of the wrought iron plate. Wrought iron is not homogeneous like steel and is formed with layers of iron and slag. Corrosion has attacked this section of plate and delaminated it requiring another type of repair - clad welding. Clad welding is where a puddle of steel is welded into the void. If the divot or void is too large, an insert may be required.

All these repair scenarios may be suggested by us or the yard, but the Coast Guard has the final say as to whether we can use an insert versus just clad welding a repair. Clad welding is a lot less expensive.

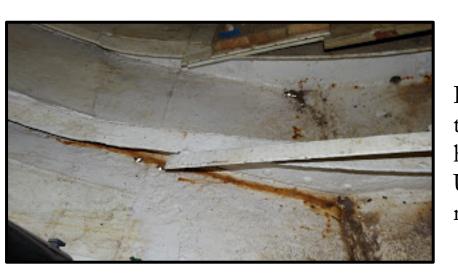
Here are holes from electrolytic corrosion just abaft the forward collision bulkhead of ELISSA. I had hoped for an insert repair in several areas, but USCG required the entire A & B strake to be renewed - a very expensive endeavor.

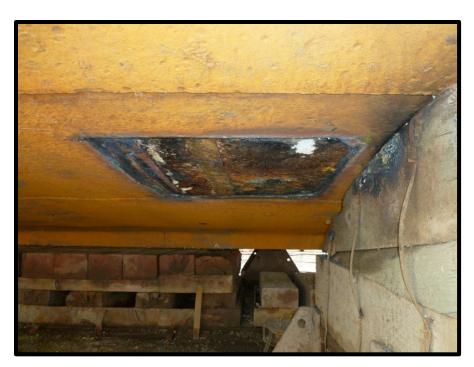
Panel cut out for USCG to test the composition and integrity of the original Lowmoor wrought iron.

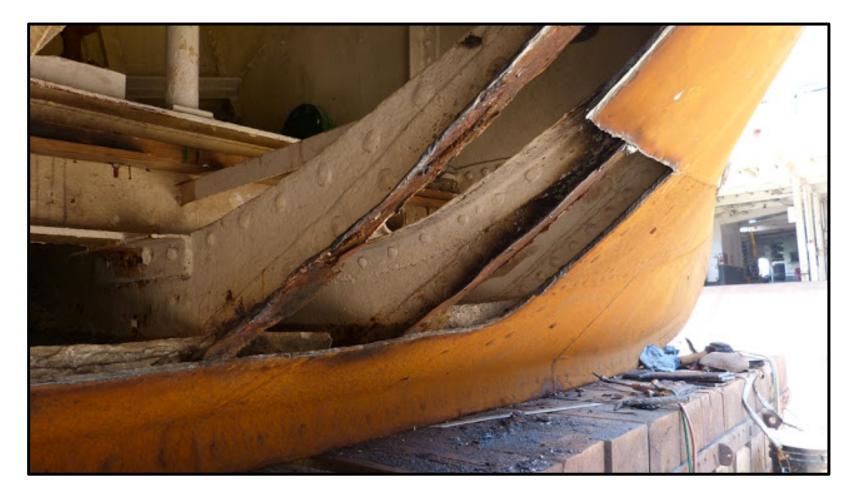
We were successful in saving 95% of the garboard plating - we did crop 4" of the garboard strake at frames 69 to 73 on the starboard side of the ship. I was very happy to see over 3/8" late thickness at the cut. The original scantlings for the shell plate at the garboard near the bow is 7/16" - so we have suffered very little wastage at this plate. Unfortunately the electrolytic corrosion does not care if the plate is thick or thin and will attack both with equal vigor.

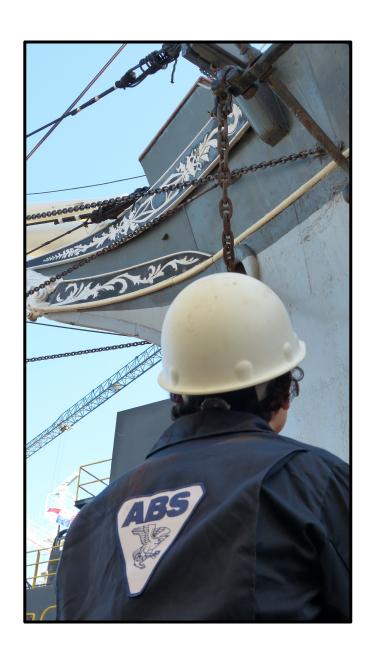
It turned out to be a lot more difficult than anyone imagined to write up a specification and protocol for radiography of the historic iron plate. Since the plate has naturally occurring silica in the form of slag layers, the x-ray may show hidden patches of corrosion that are actually just slag lines.

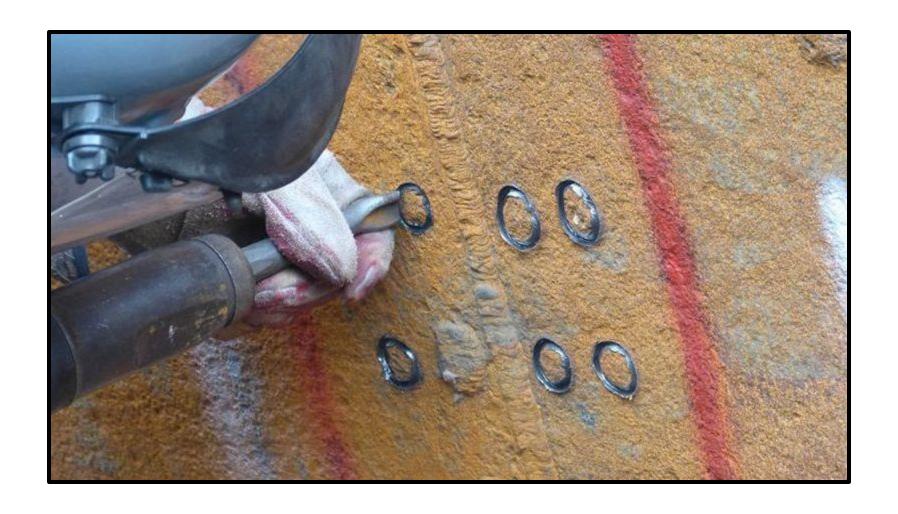
"Frenching" rivet repair ~ step one. Frenching a rivet is an accepted USCG repair to damaged rivets. The use of clad welding onto the rivet point is a bad practice and to be avoided.

A majority of the rivets on ELISSA are repairable by using a repair called "frenching", according to Terry Jagielski of Hansen Industries in Toledo, Ohio (an expert in rivet repairs). Rivets that had to much of their point corroded needed renewal.

The rivet repairs and any renewals will follow the guidelines outlined in the Coast Guard's NVIC 7-01

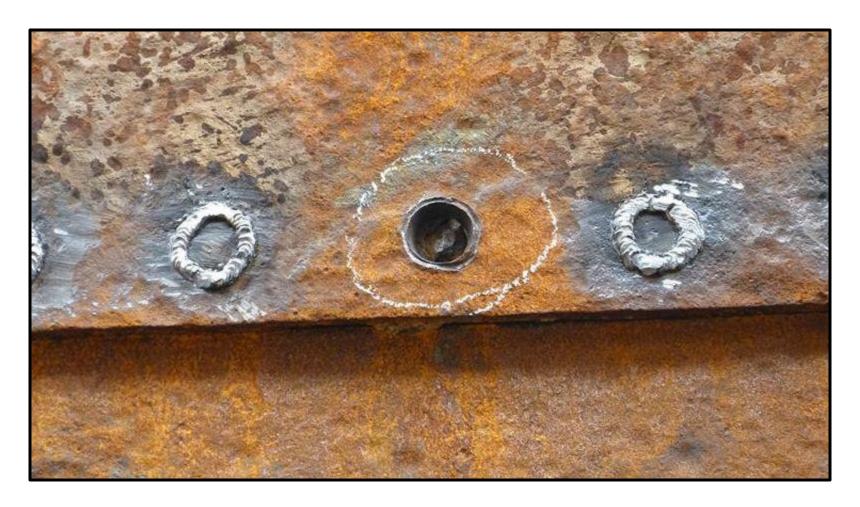
Broken rivet between two finished "Frenched" rivets

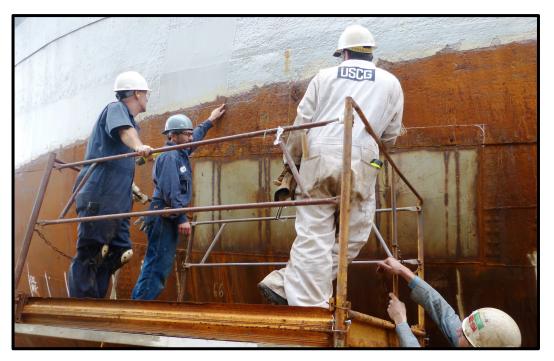
A fracture in one of the plates was discovered and additional plate was cropped for "riveted renewal since it was at and above the waterline and visible.

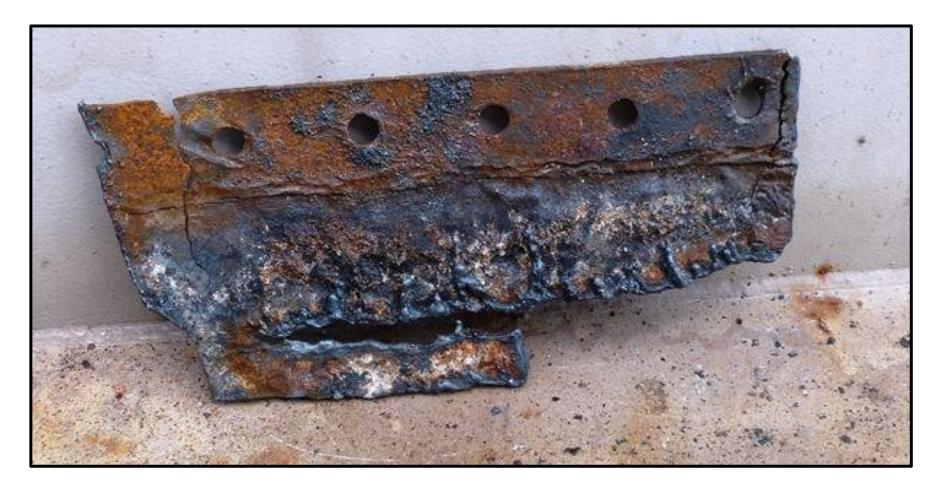
Section of fractured iron plate to be renewed by riveting new plate

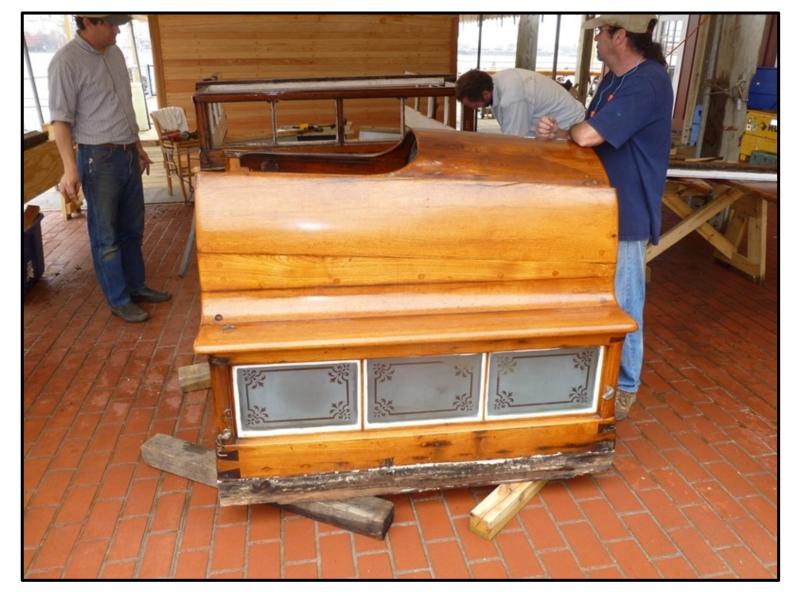
1877 aft companionway scuttle showing rot in base and joints. A new one was built to the exact dimensions with identical etched glass panels.
