TALE OF A RIVET ELISSA 2012-13 Hull & Deck Restoration

~ELISSA REDIVIVUS~ 2012 RESTORATION

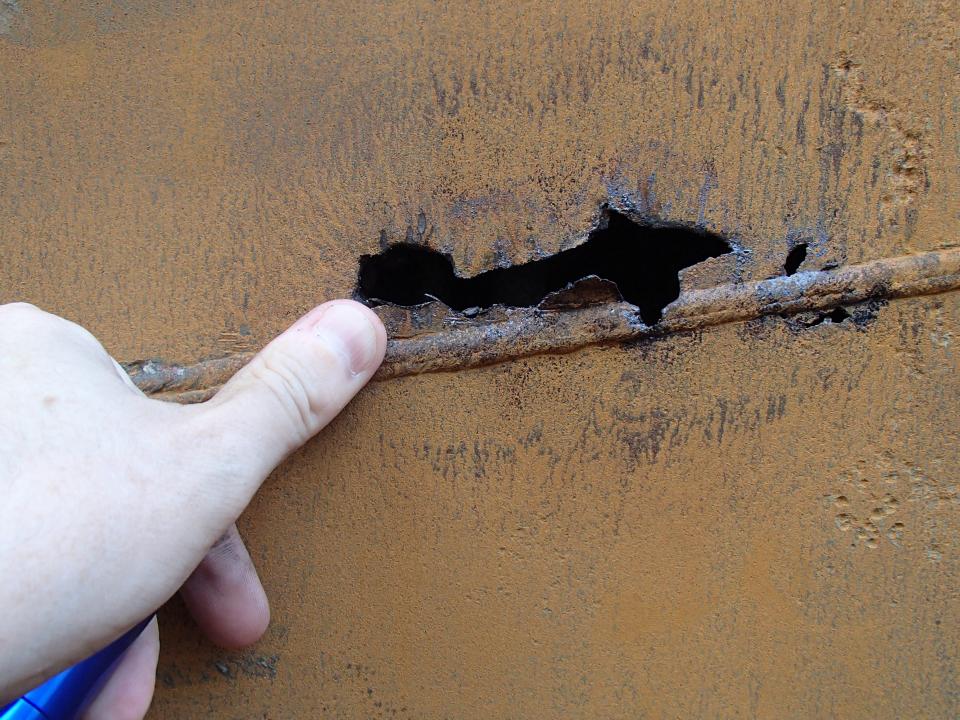
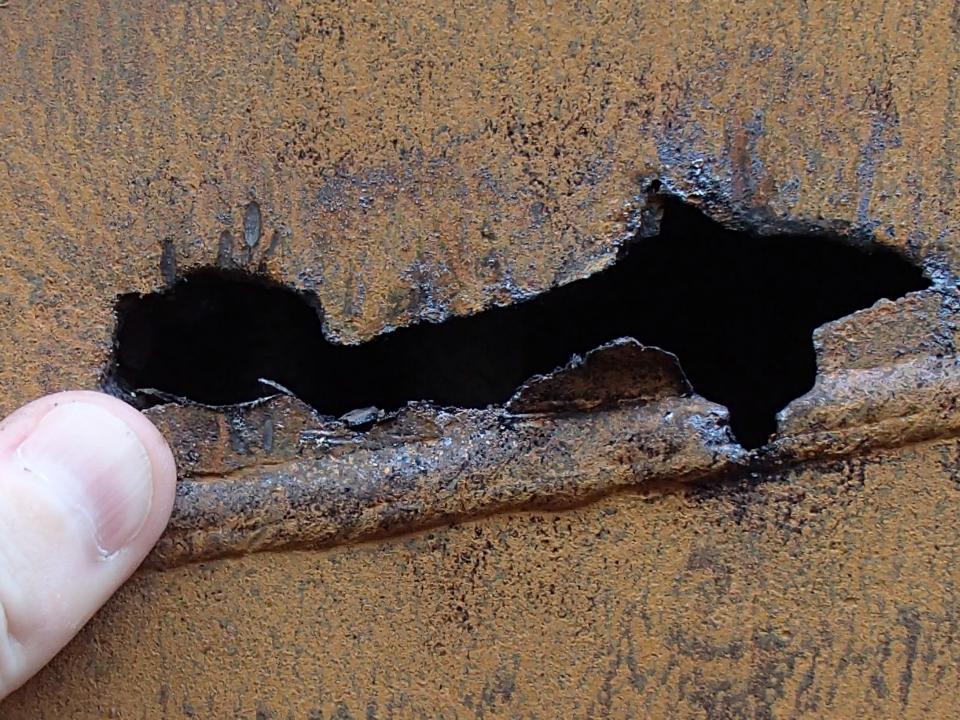
The concentrated pressure of 20 tons on an area no larger than a postage stamp revealed areas of electrolytic corrosion not uncovered during the prior dry-docking in 2011.

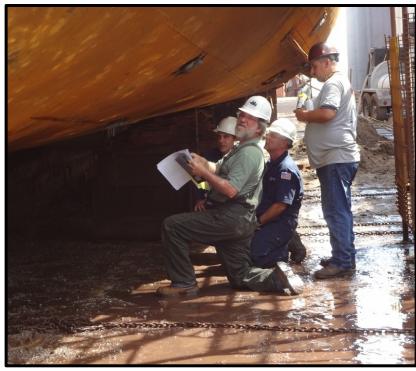
When the ship was hauled in early January 2011, the first sign of a problem was the disappearance of over one dozen of the 55 sacrificial zinc anodes on her underwater body. This rate of deterioration was never before at any of her numerous prior dry dockings.

After removing the marine growth, more problems surfaced -problems that had never been seen before. Inspectors found many
small pits (some of which penetrated entirely through the hull), as
well as numerous wasted rivets (another first). It was determined that
what happened to ELISSA's hull was severe electrolytic corrosion and
that it taken place since the last dry-docking in January 2008.

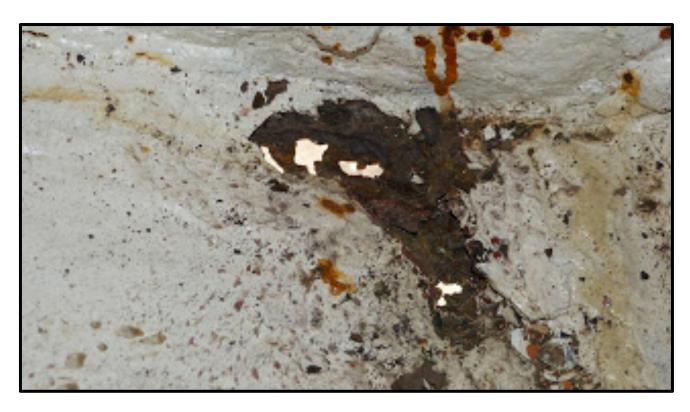
Here are holes from electrolytic corrosion just abaft the forward collision bulkhead of ELISSA. I had hoped for an insert repair in several areas, but USCG required the entire A & B strake to be renewed - a very expensive endeavor.

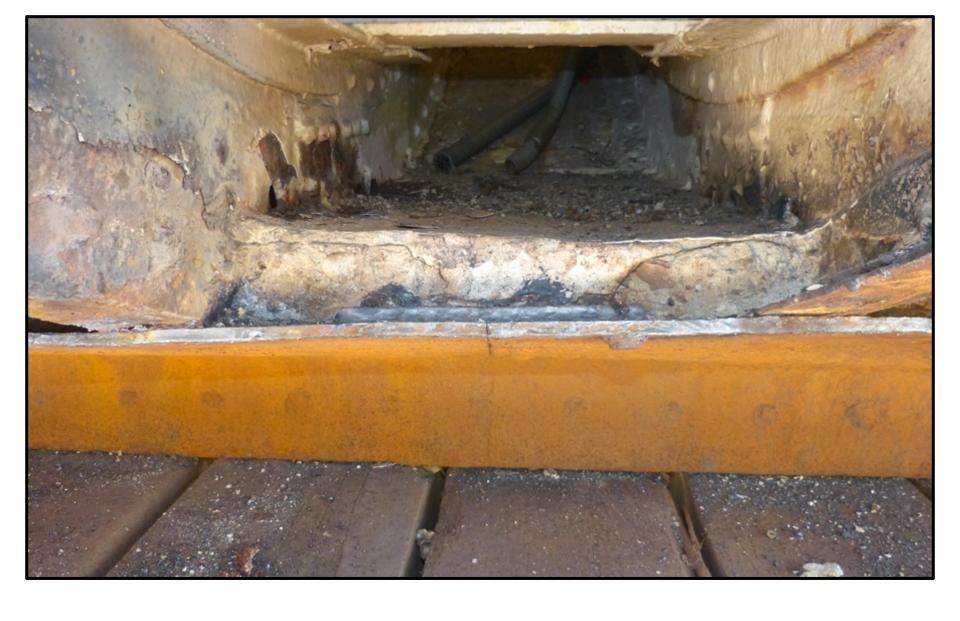
The cropped garboard plate showing the concrete and butt plate.

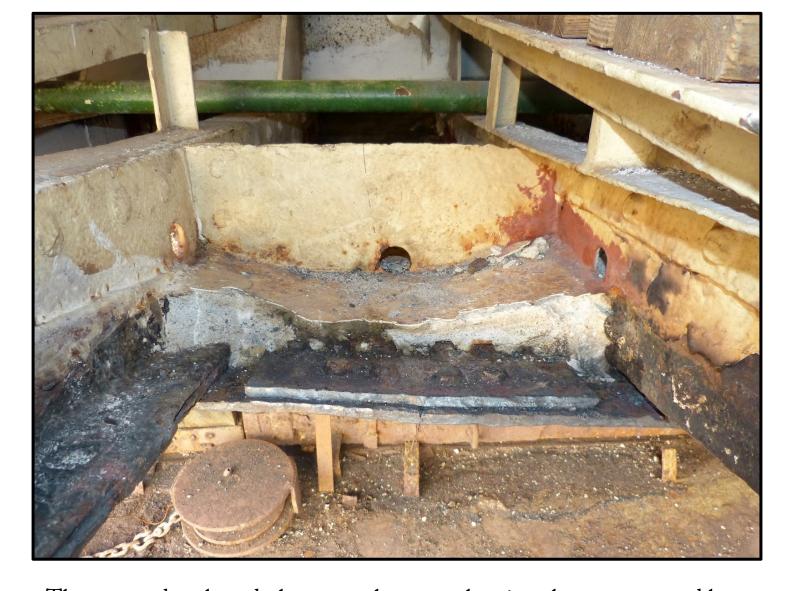
The cropped garboard plate near the stern showing the concrete and butt plate, and wash plates with limber holes in the frames. Note the shaping of the concrete to direct water to the limber holes.

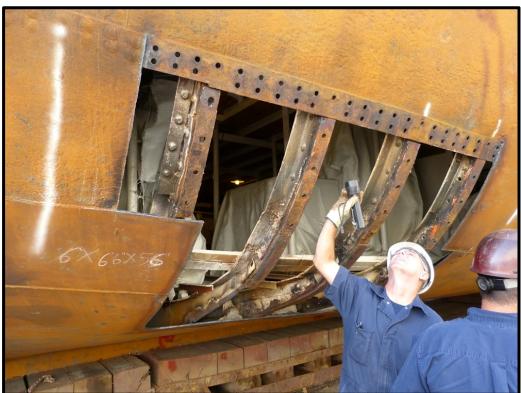
The framing at frames 63-66 appeared sound, but the plate was still too thin at about 1/4"

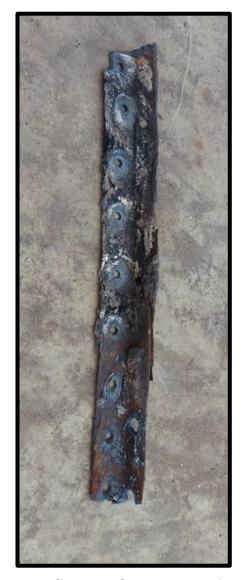
Cut out frame flange for renewal.

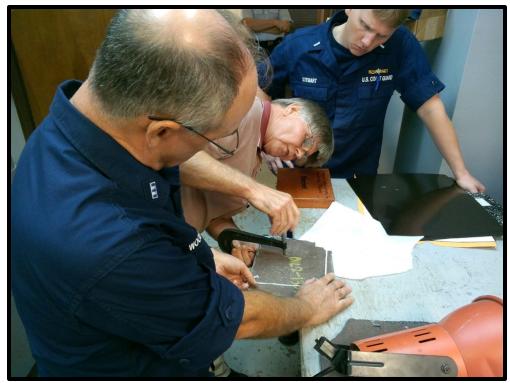
Measuring depth of pits.

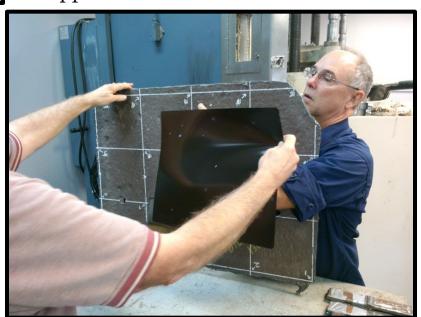
Test coupon of new steel plate welded to original 1877 iron plate sample to test weld integrity by pulling to destruction.

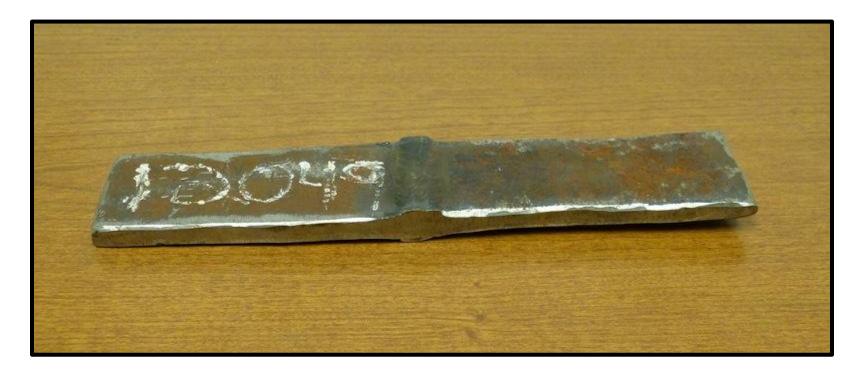
A certified shipyard welder was further required to weld up a test coupon to ensure they could safely join modern steel to 135 year old wrought iron.

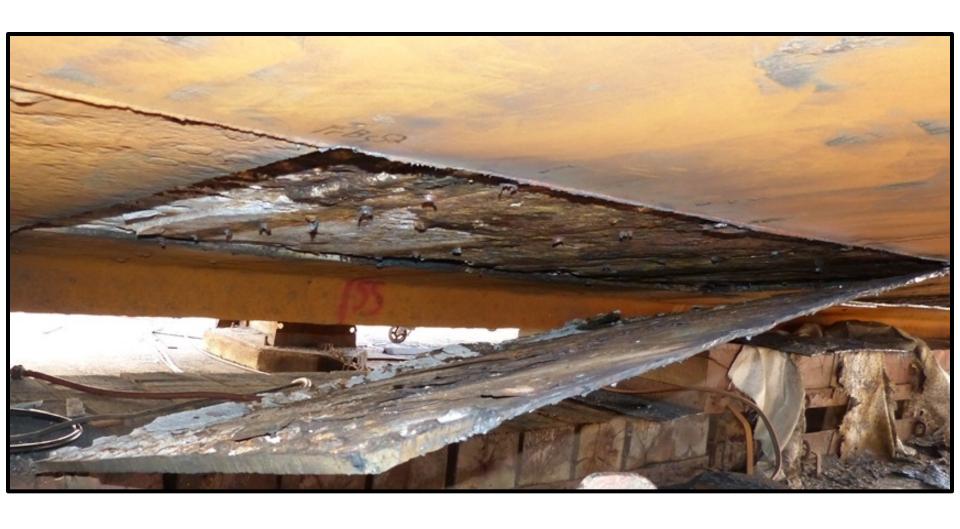
Original 1877 wrought iron plate - A strake at frame 55 - note clean white 1877 Portland cement.

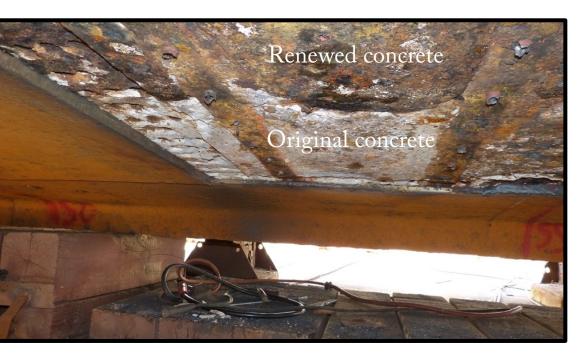
Rust stained concrete is material that was renewed during various repairs over the years.

White concrete is "original" Portland cement" applied during construction in 1877.

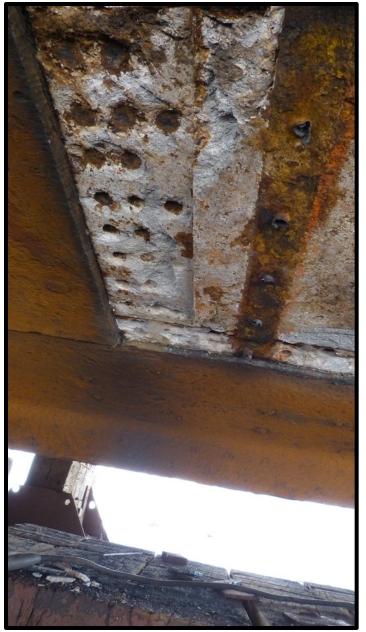
After 135 years under concrete, the rivet heads are still as perfect as the day they were driven.

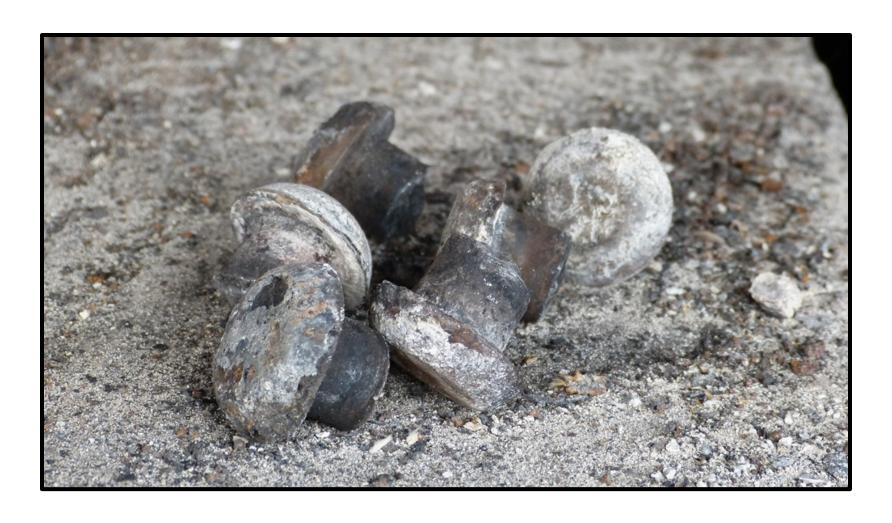
Rivets from 1877 ~ still in good condition

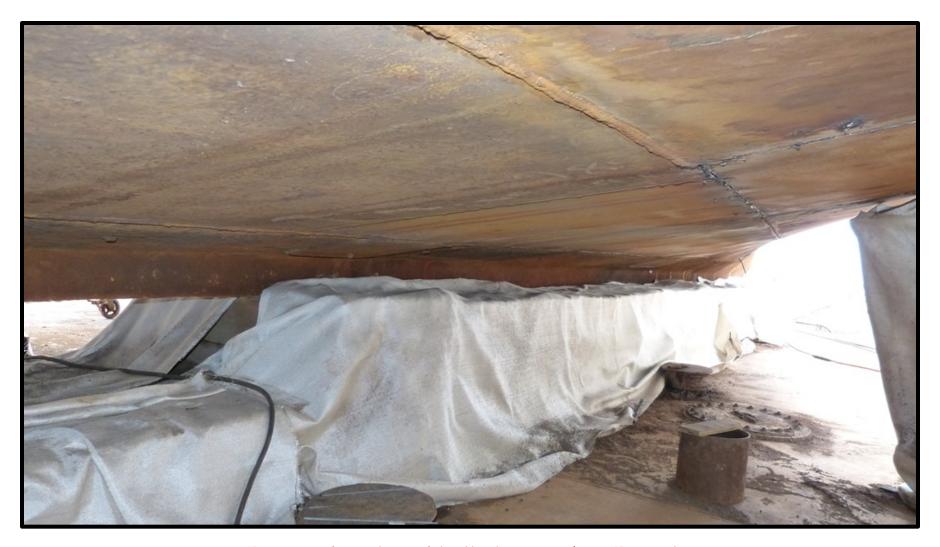
Renewed starboard hull plate on A & B strake looking forward.

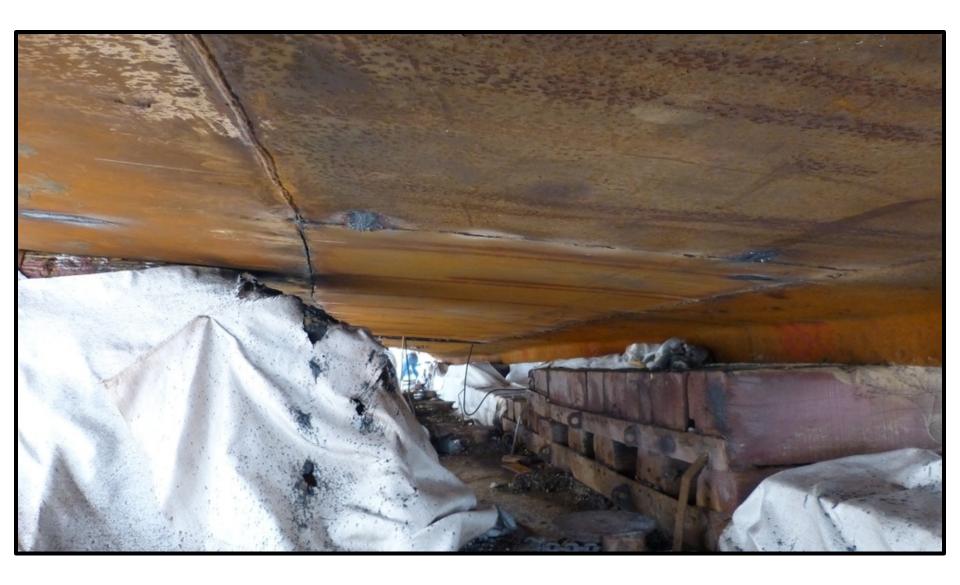
Renewed starboard hull plate on "A" & "B" strake looking aft.

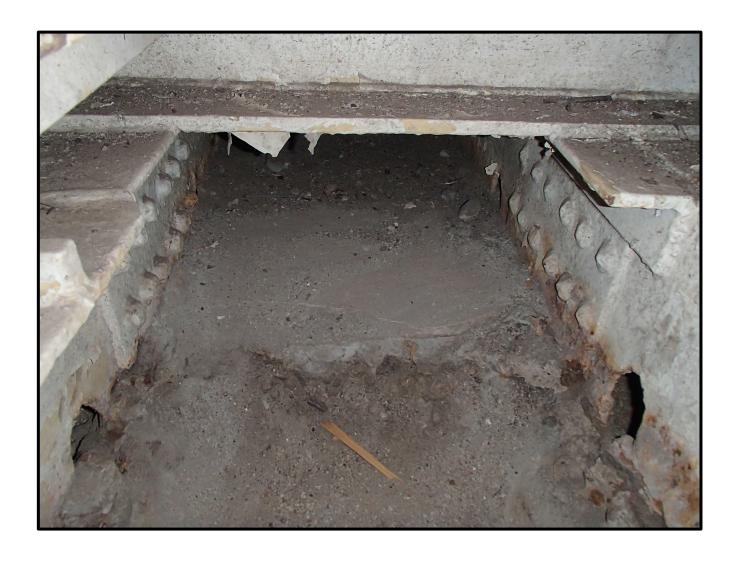
A typical frame bay and the concrete. The concrete served to allow water to drain through the limber holes in the frames and to serve as chafe protection from the abrasive action of salt water constantly washing over the iron plating - year after year.

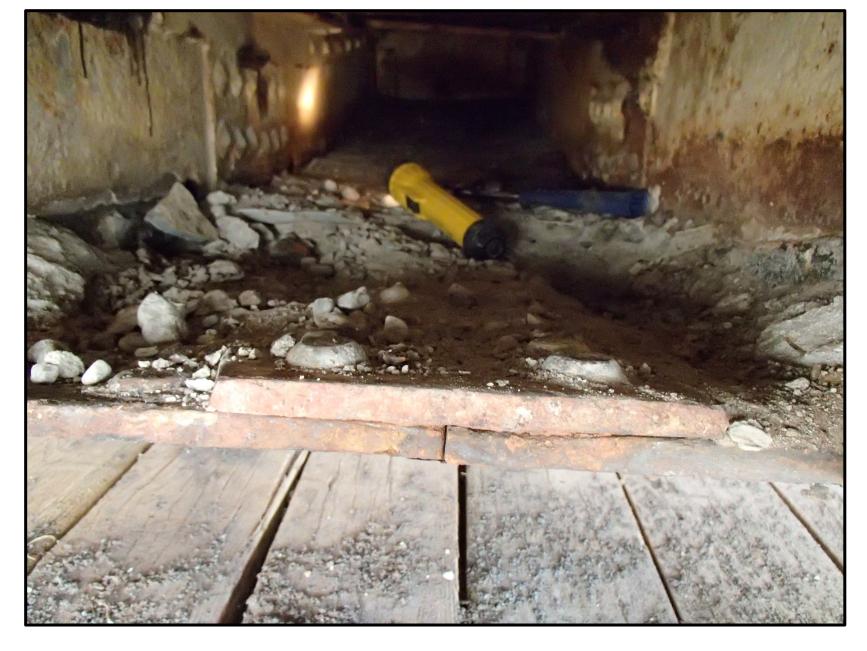
A butt plate in perfect condition after 135 years.

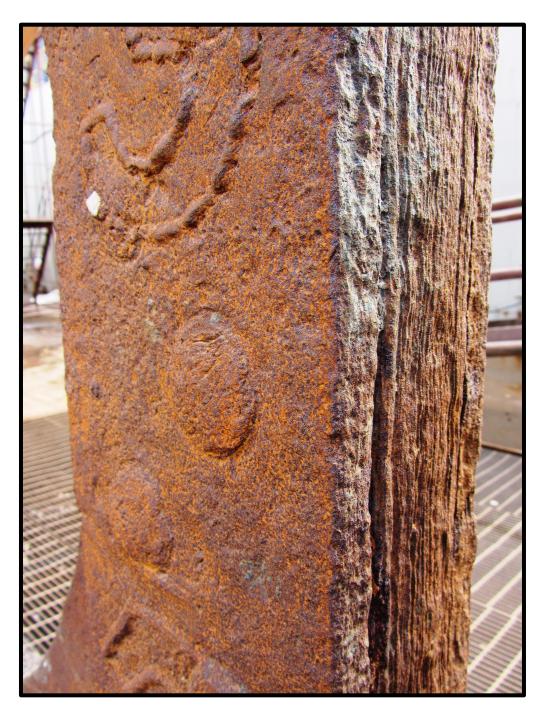
Stern post and propeller aperture.

Notice the layering and tree bark like appearance of the 1877 wrought iron..

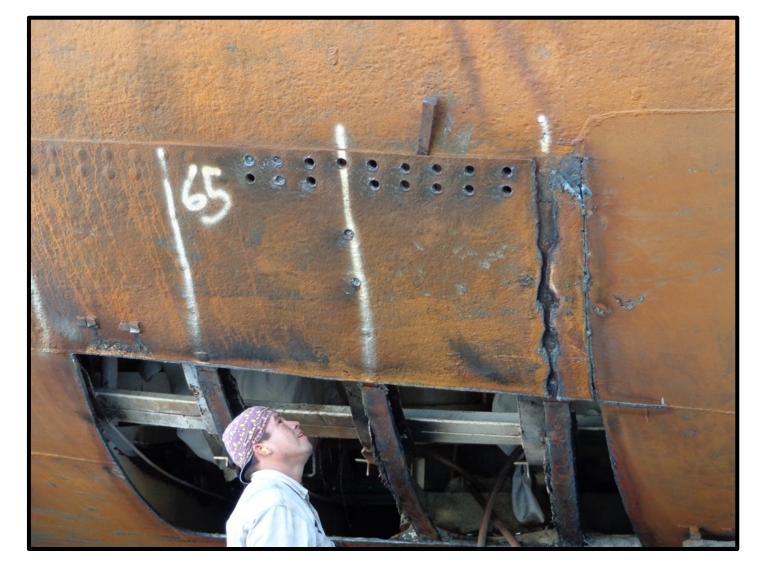
Washing off rivets and burning through hull plate. The wedges assisted in prying back the plate enough to knock out the rivet heads. This was done to facilitate a welded to rivet transition.

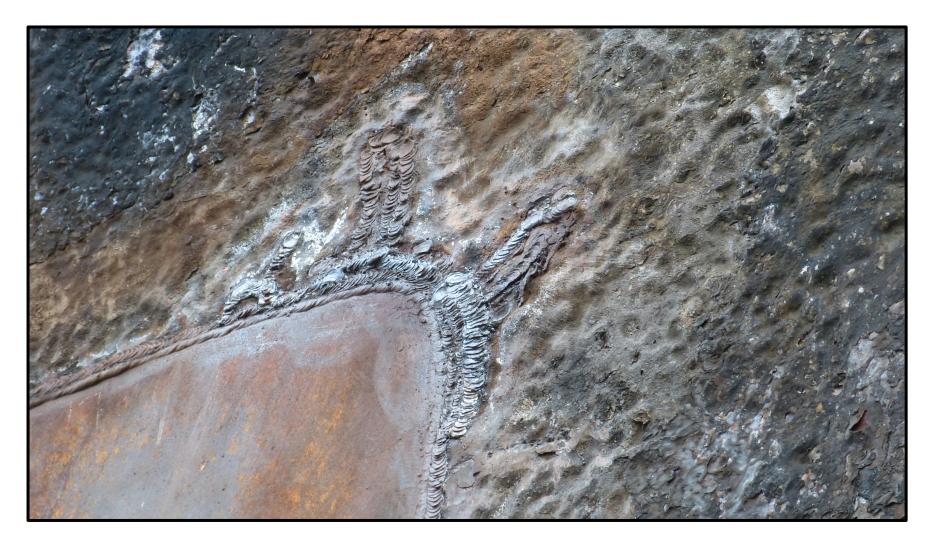
Relieving cuts made in the new plate to help ensure internal stresses created by welding are released and not locked into the plate.

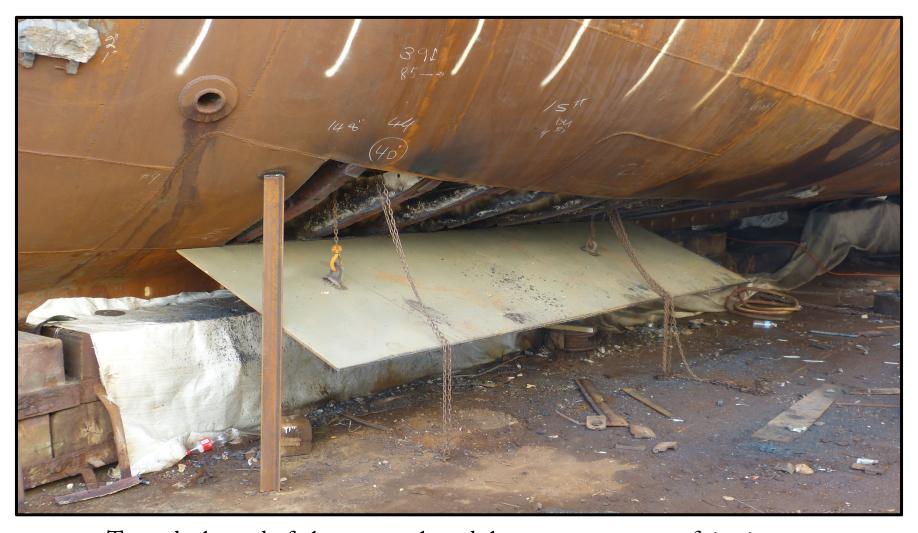
Towards the end of plate renewals and the commencement of riveting. In all, almost 1800 sq. ft. of hull plate was renewed.

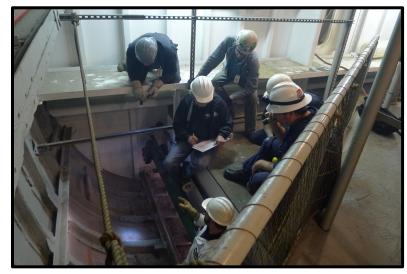
"Frenching" rivet repair ~ step one. Frenching a rivet is an accepted USCG repair to damaged rivets. The use of clad welding onto the rivet point is a bad practice and to be avoided.

A majority of the rivets on ELISSA are repairable by using a repair called "frenching", according to Terry Jagielski of Hansen Industries in Toledo, Ohio (an expert in rivet repairs). Rivets that had to much of their point corroded needed renewal.

The rivet repairs and any renewals will follow the guidelines outlined in the Coast Guard's NVIC 7-01

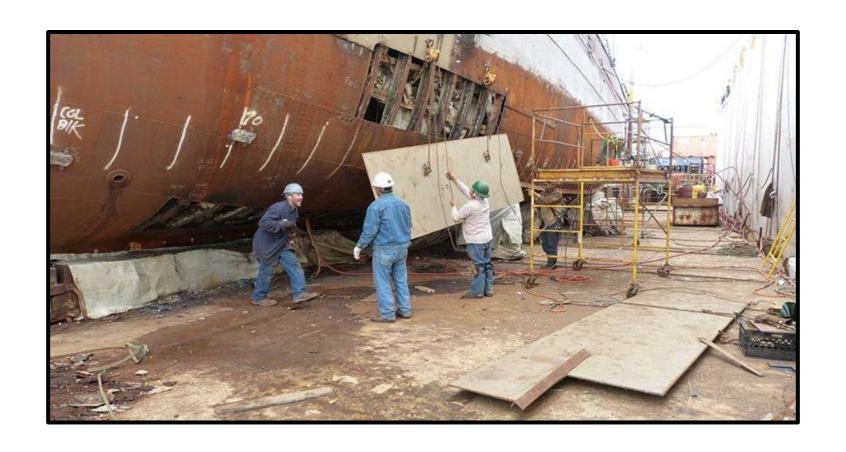
Fitting new steel plate in preparation for drilling, reaming out, and riveting.

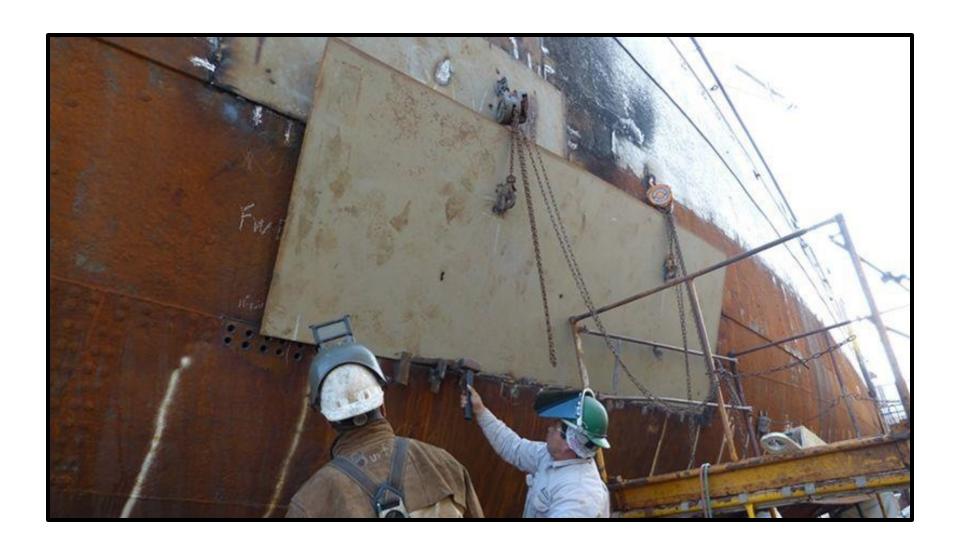
Dogging new steel plate.

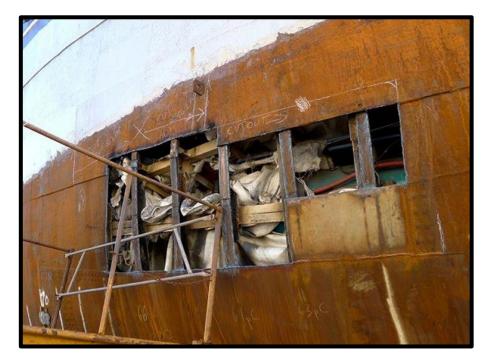
A fracture in one of the plates was discovered and additional plate was cropped for "riveted renewal since it was at and above the waterline and visible.

Section of fractured iron plate to be renewed by riveting new plate

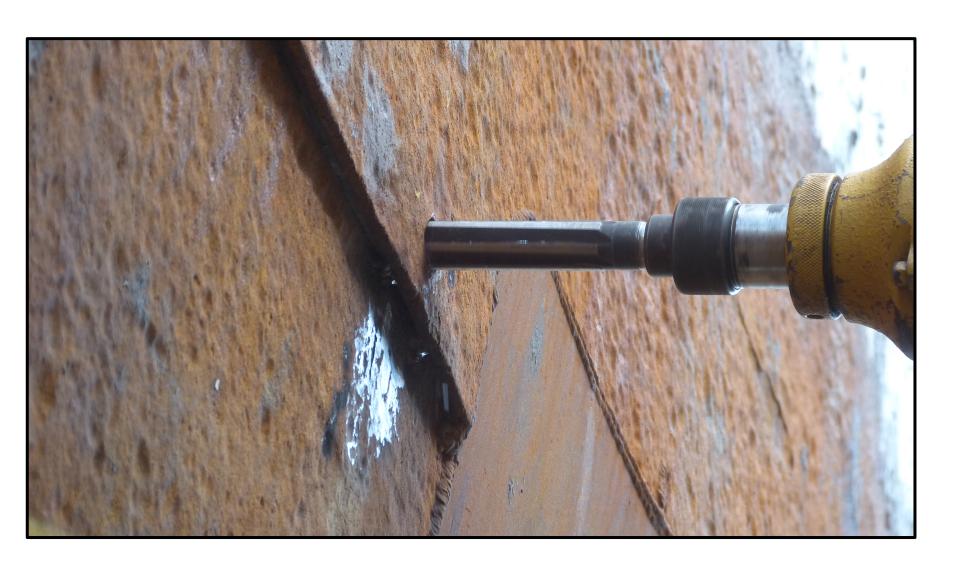
Reaming out old rivet hole for new rivet.

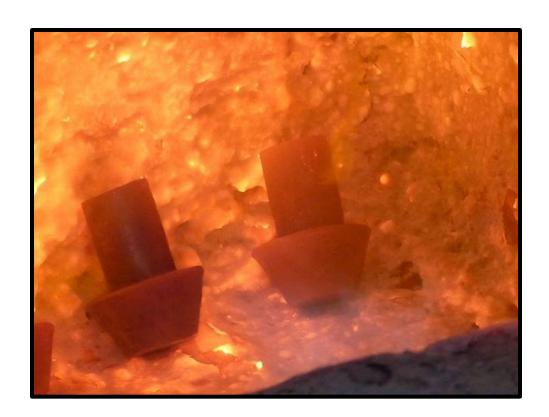
Rivets being brought to an orange heat – too hot and they burn; too cold and they do not peen over properly.

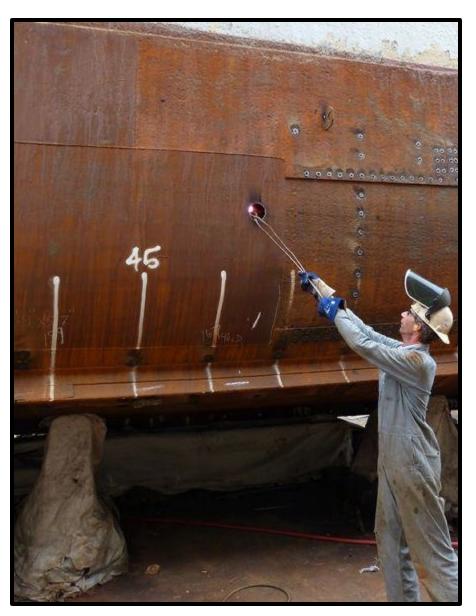
"Hot Rivet" is the cry as it is passed through a hole cut into the hull. This hole will be welded closed later.

Later a spigot patch is used to closed the round hole.

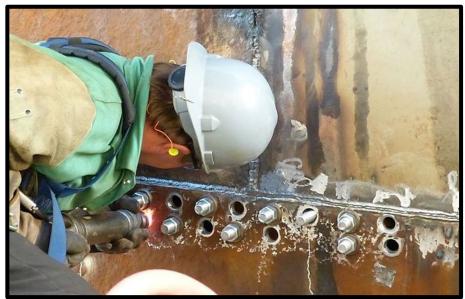
Plate bolted up ~ rivets are placed in empty holes and then the bolts are removed and the remaining rivets passed.

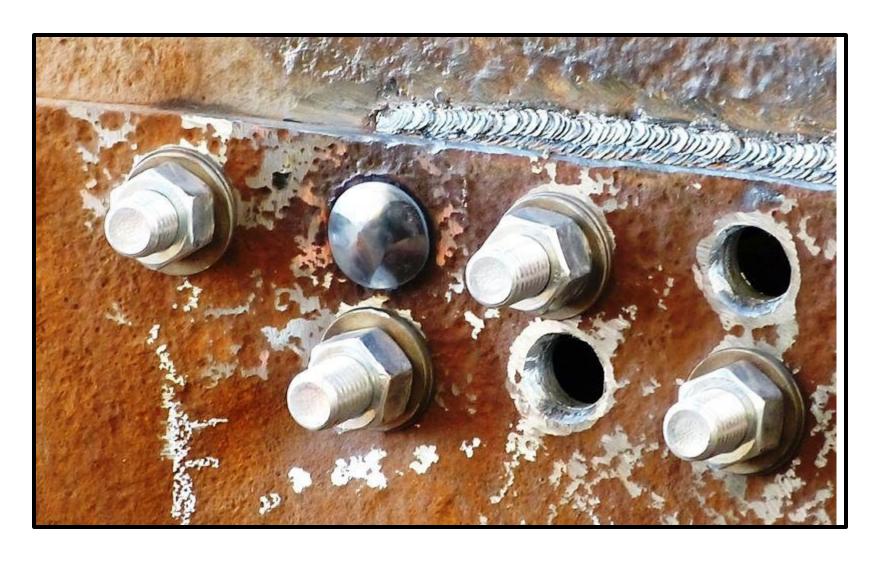
A shinny new rivet~ the rivet gun polishes the rivet point as it works the rivet in the chamfered hole. This is an example of a welded to rivet transition.

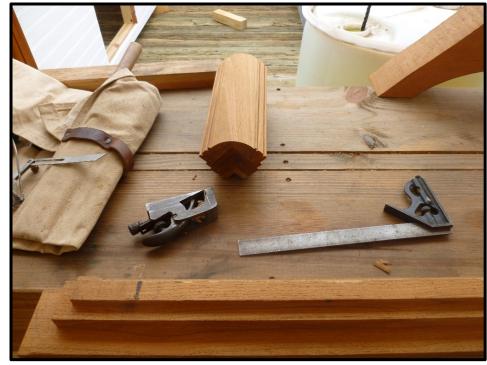
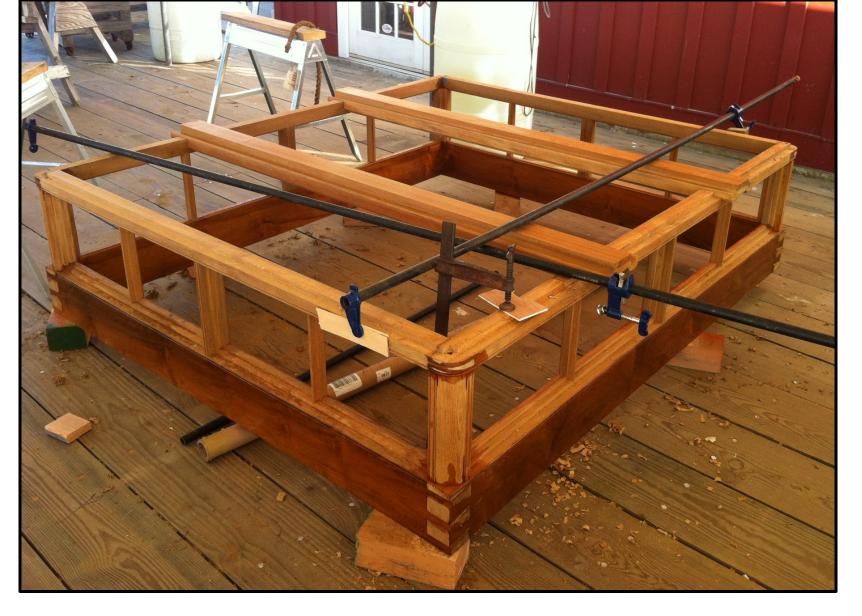
A new teak skylight replicated from the 1877 teak skylight.

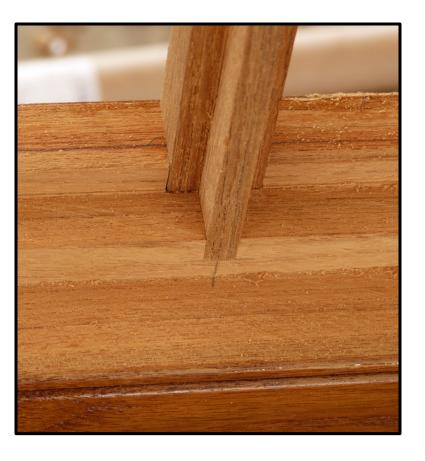
The new skylight being glued up and awaiting the new glass panels with an exact replication of original etched design.

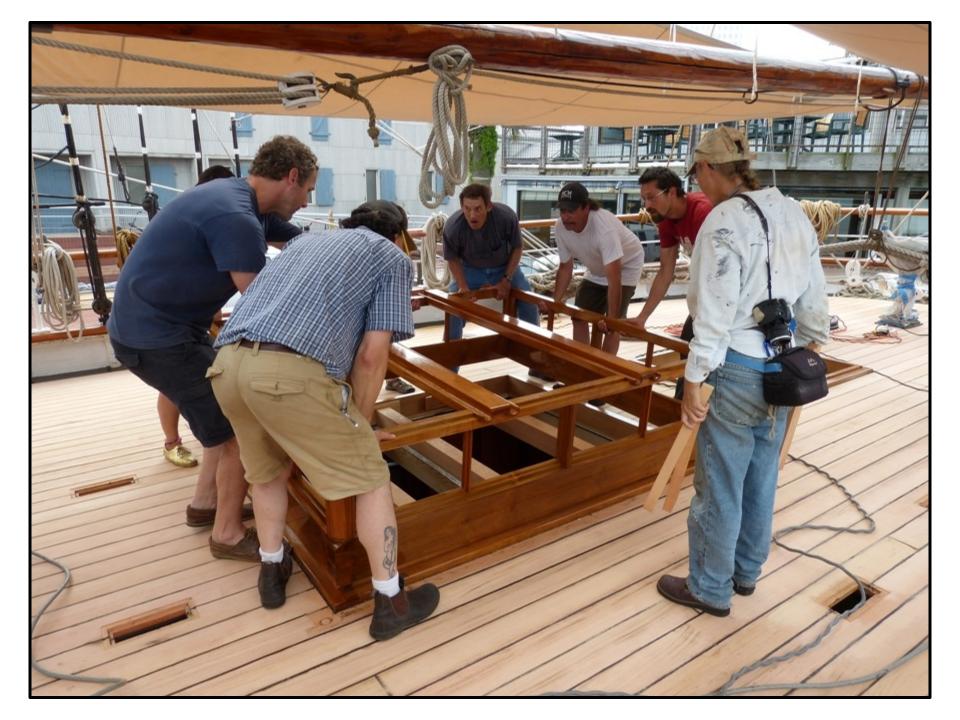
1877 aft companionway scuttle showing rot in base and joints. A new one was built to the exact dimensions with identical etched glass panels.

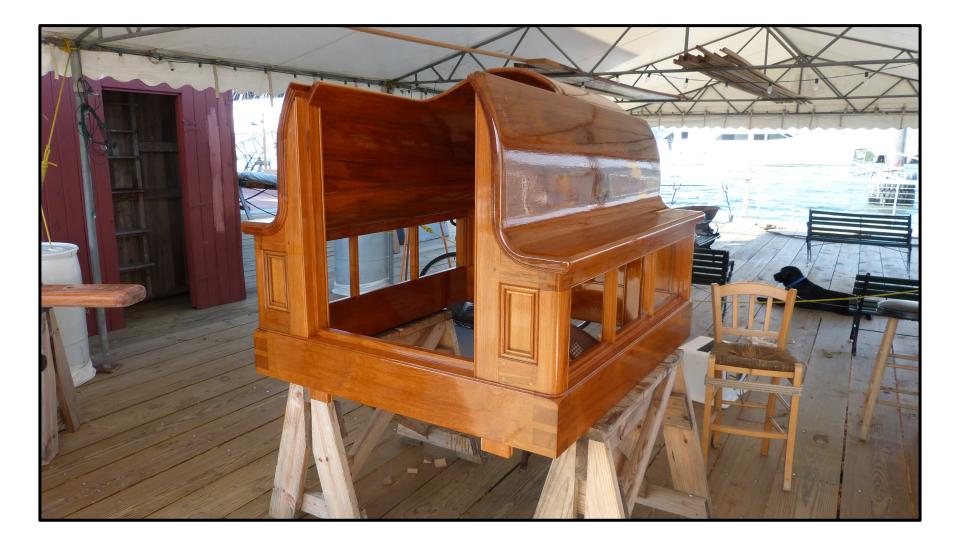
A new aft companionway teak scuttle was built.

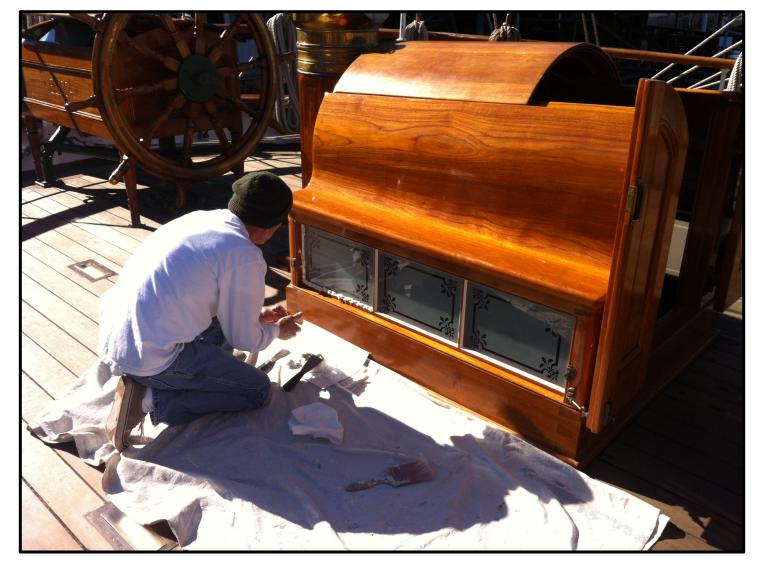
Glazing the new etched glass panels in the renewed aft companionway scuttle. We used Burma teak from the 1980 restoration of ELISSA to rebuild the skylight and scuttle.

Burma teak has a glow new plantation teak lacks.
